Major Power Plant in Turkey Protects Stack and Facility Equipment with ChemLine® Coatings

ChemLINE®
CASE STUDY

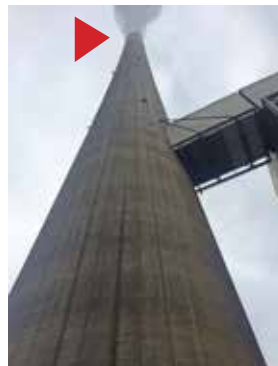
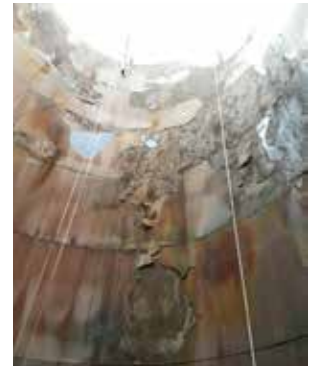
One of the largest thermal coal-fired power plants in Turkey had a serious coatings corrosion problem on the inside of their 180-meter carbon steel stack, at the height of 170 meters. They had previously lined this area with a vinyl ester coating, however it did not even last 10 months before serious de-lamination problems occurred (as shown in photos below).

When plant personnel discovered coating de-lamination problems inside the stack (shown by red arrow in photo), they asked if ChemLine® could also handle these severe conditions, where a mixture of different chemicals — 70.295% Nitrogen, 12.858% Water, .005% Sulfate, 11.769% Carbon Dioxide, and 5.07% Oxygen — operate in temperatures of 140°F/60°C and at times reaching 233°F/112°C.

After reviewing the extensive project reference list from MarineLine Turkiye for similar projects, including coatings work done for EREN ENERGY and others, the power plant contracted for ChemLine® lining within the stack.

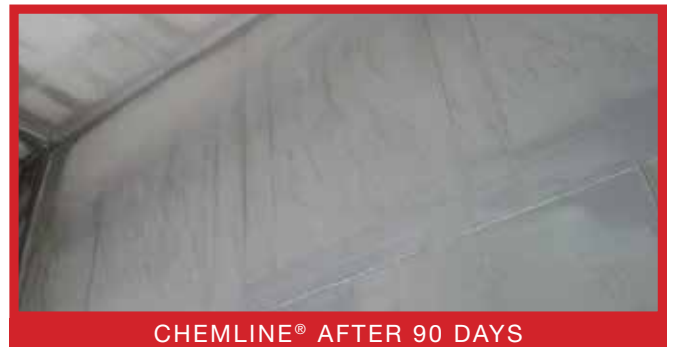
After 90 days of operation, the power plant stopped production to check the condition of the ChemLine® coating. The inspection showed the coating in near-perfect condition (as shown in this 90-day inspection photo of a close-up of the stack tunnel presented in the photo area above). The customer is pleased with the result and will conduct a through review after one year of service, with plans for future ChemLine® protective coating projects.

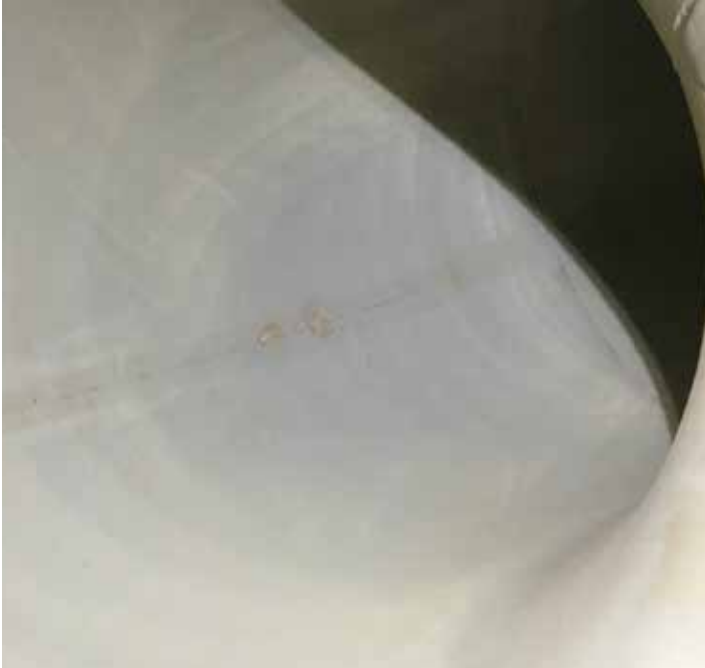
CONDENSER LINE AFTER 1 YEAR CHEMLINE® SERVICE

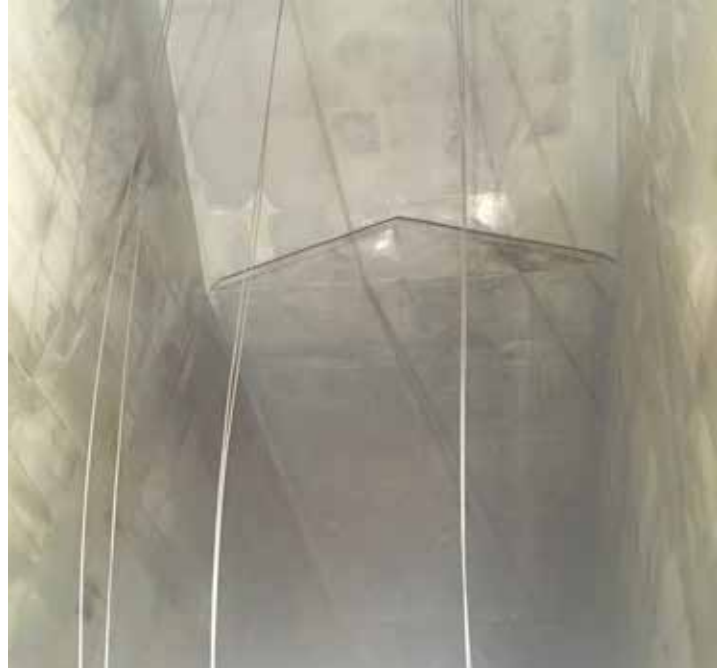
FGD UNIT AFTER 1 YEAR CHEMLINE® SERVICE

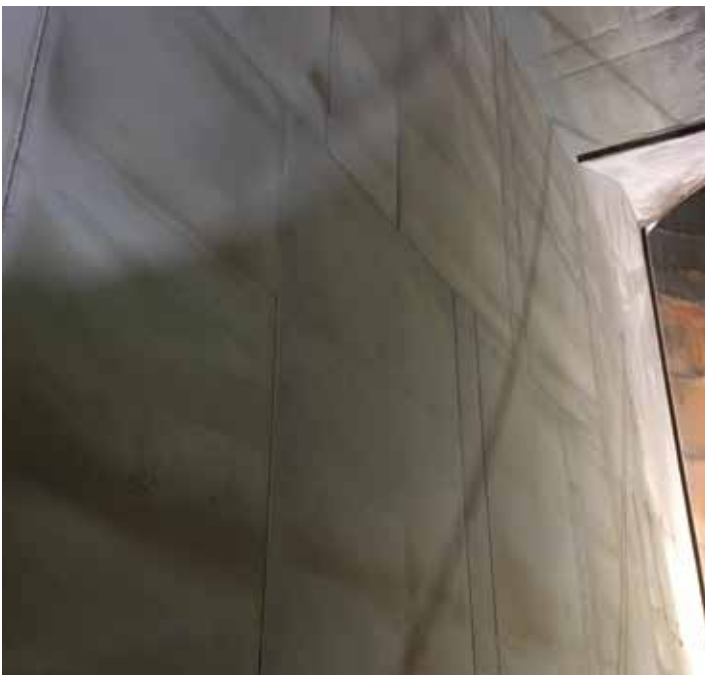
FGD UNIT AFTER 1 YEAR CHEMLINE® SERVICE

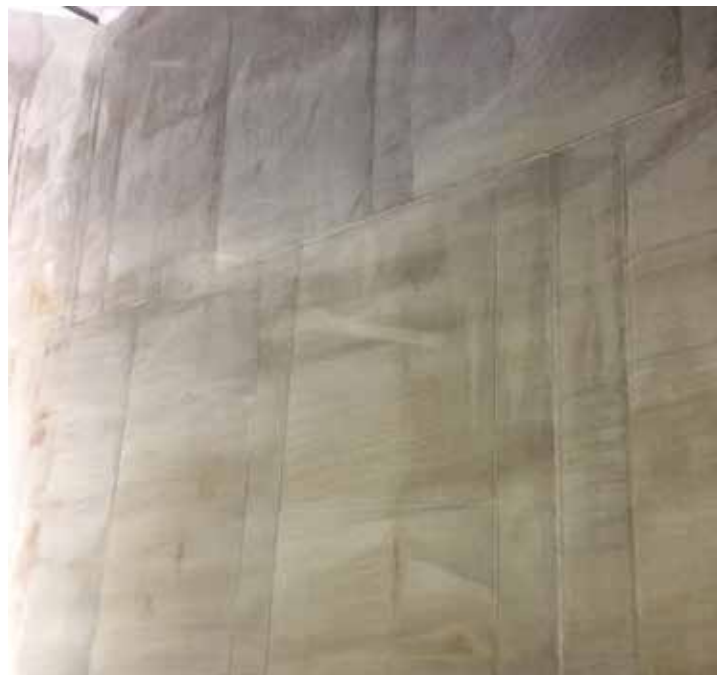
FGD UNIT AFTER 1 YEAR CHEMLINE® SERVICE

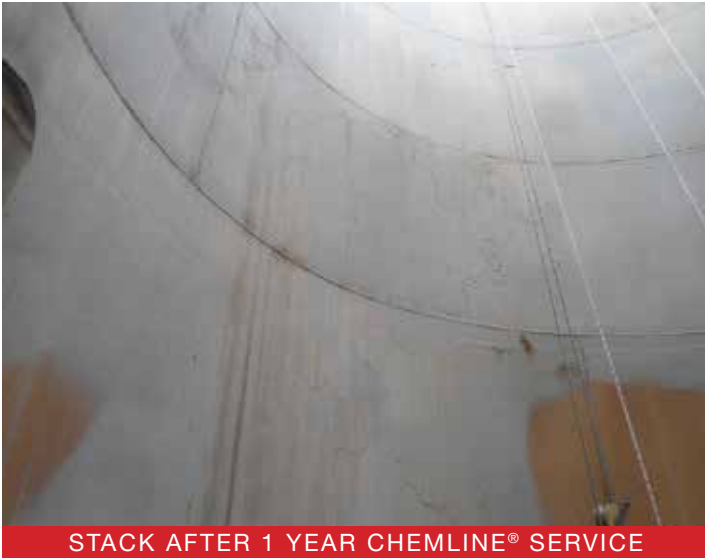
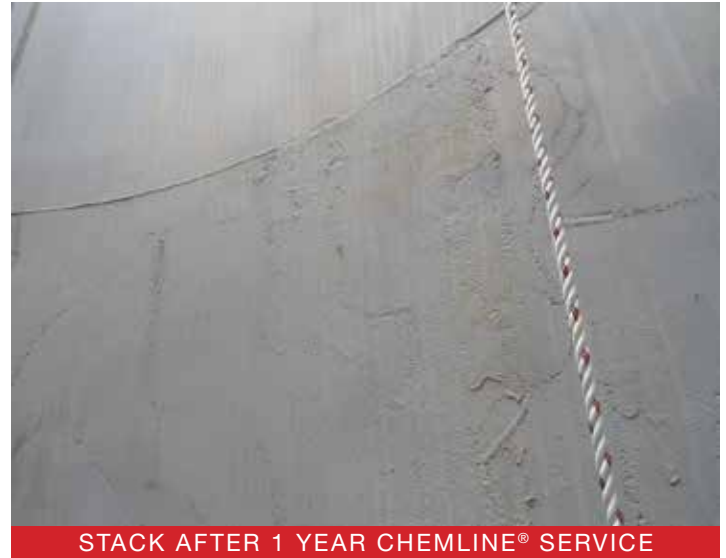
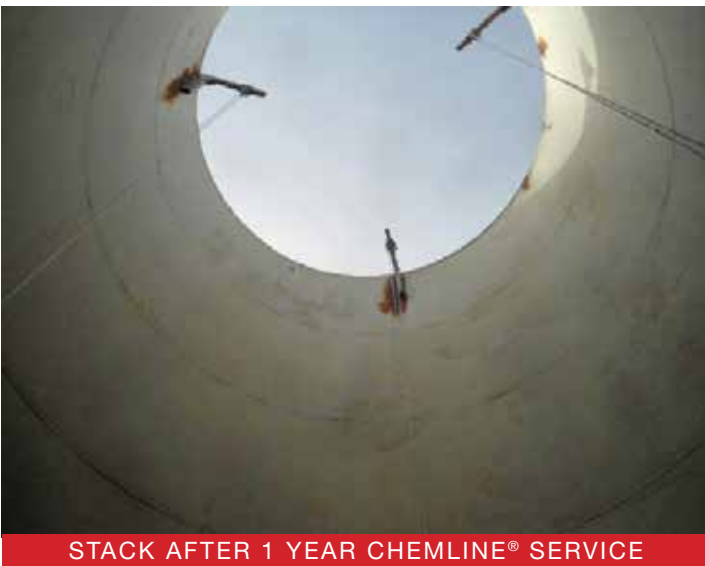
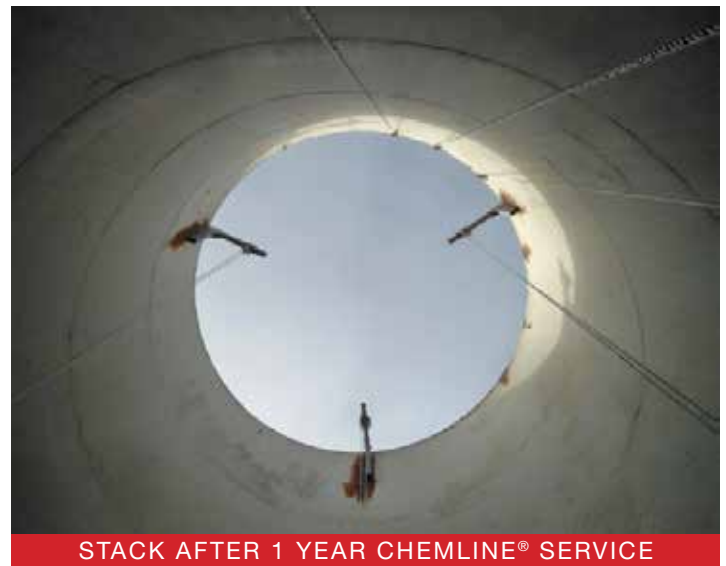
1-Year Followup – Stack

The ChemLine® coating in the stack was also inspected after 1 year of service, with no problems found. The rust shown at the top of the stack is rust stain

from the manifolds, and not any corrosion effect.
