An Answer Close to Home

Pipe Lining Solution

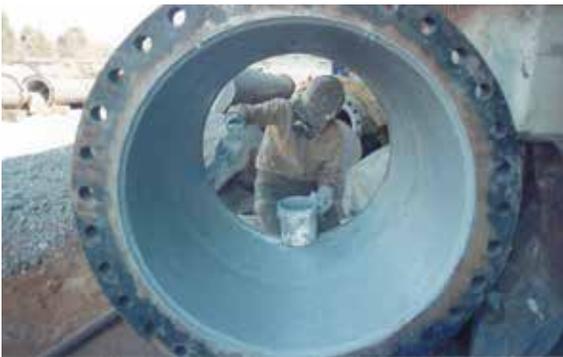
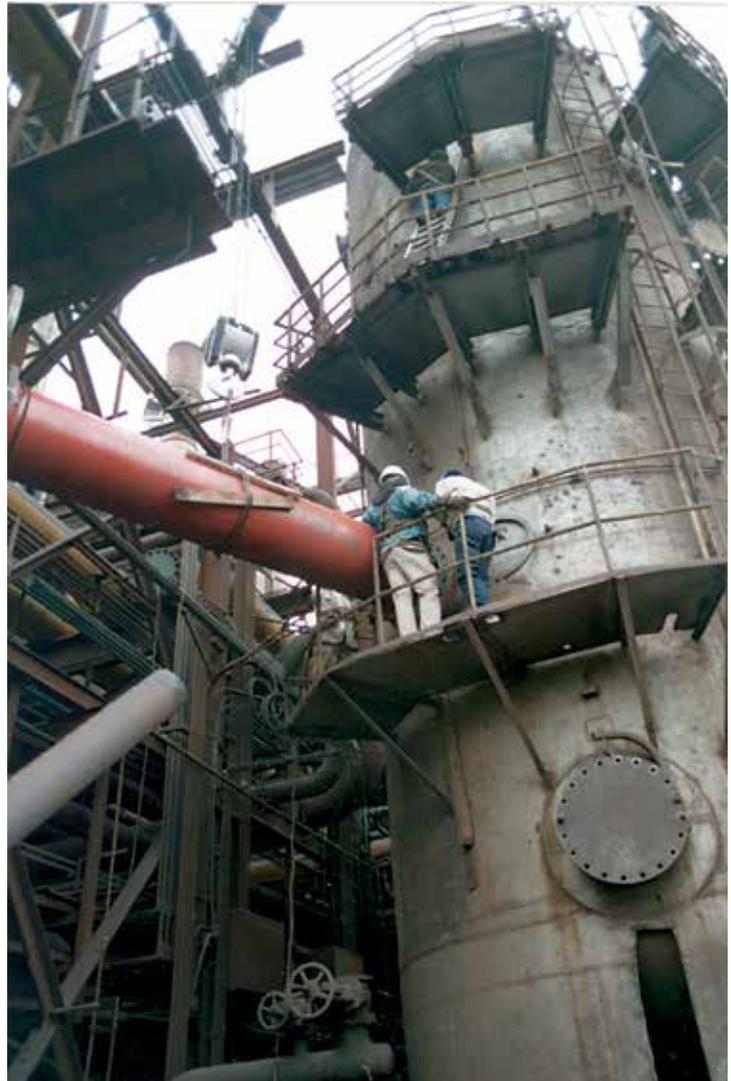
(Above) Installing pipe lined with ChemLine® coating to the scrubber, which is also lined with ChemLine® coating. (Left) Pipe section leading into scrubber lined with reinforced ChemLine® coating.

The first step was to prepare the pipe by gritblasting with 16/30 white sand grit to a profile of about 3-4 mils. A base coat of ChemLINE® was applied as the primer, as the coating has superior bonding qualities, and allows for rapid re-coat intervals. That was followed by a fiberglass sheet of ChemLINE®-based material approximately 40 mils DFT – dry film thickness.

In addition, some ChemLINE® putty was used to fill in gaps and irregularities in the pipeline surface. All of the pipe's flange radius area was re-sanded before the final topcoat of a ChemLINE® was applied to 40 mils DFT average. Of the 20 pieces of pipe, 19 were heat cured with one heater at 120°C for eight hours. The remaining pipe was heat cured with two heaters, one on each end of the pipe.

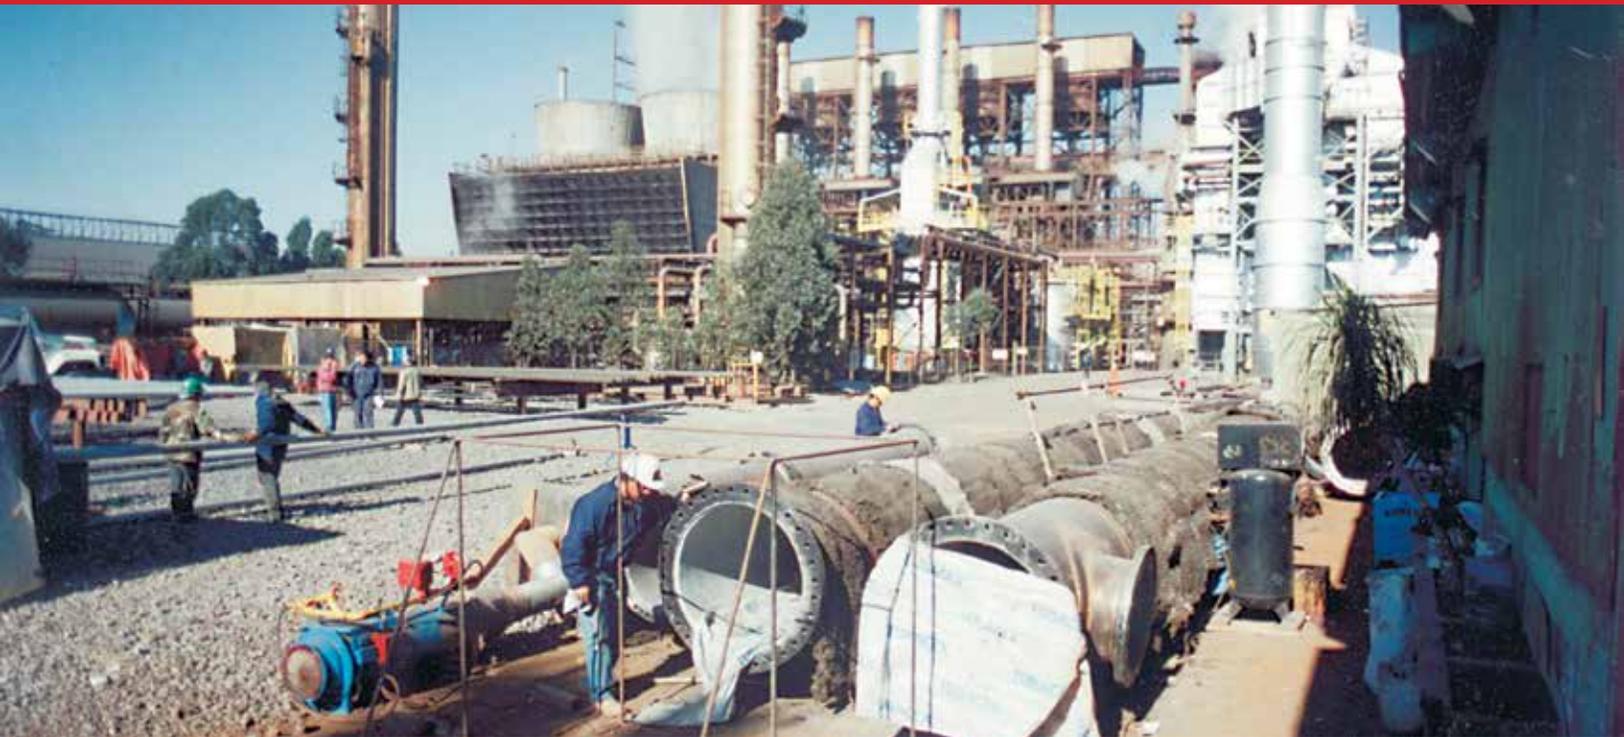
(Above) Spark testing the ChemLINE® lining of the pipe before installation.
