ChemLine® Coatings Offer Advanced Corrosion Protection for Demanding Power Industry Needs

ChemLINE®
CASE STUDY

Protecting Booster Fans in FGD Stacks

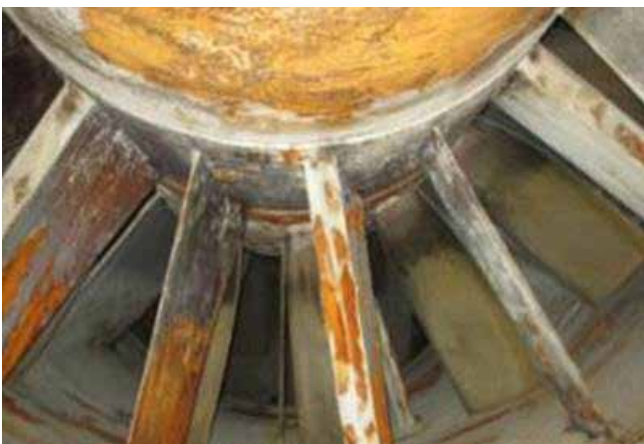
(Left) At this coal-fired plant, the carbon steel booster fans in the FGD stacks exhibit severe corrosion problems and need to be coated. (Right)

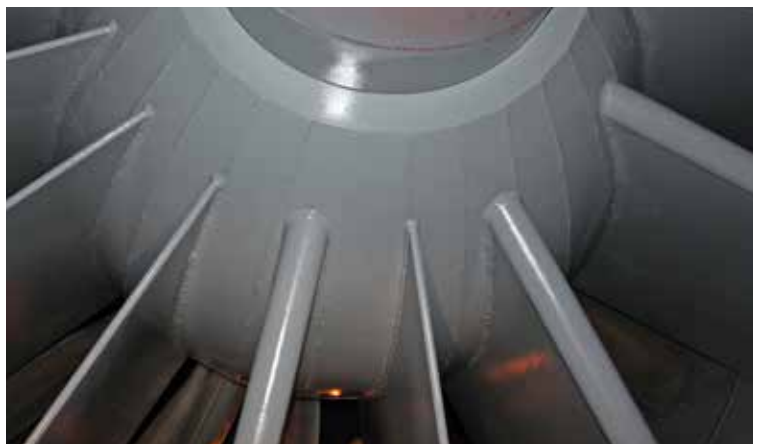
The fan blades now coated with ChemLine® in this close-up inspection photo shows excellent performance against the corrosive flue gas/chemical service conditions.

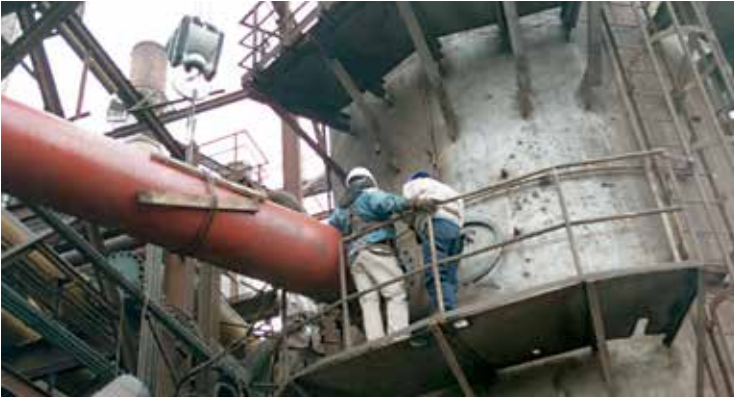
(Left) At this steel bar- and wire-producing facility, severe pipe and scrubber corrosion is caused by gas containing 5% Hydrogen, 5% Sulfuric Acid, and a slurry of iron dust, carbon and water, that travels through a 120-meter pipeline and empties into a large

scrubber. Temperatures of this mixture can reach as high as 248°F/120°C. (Right) Both the pipe and the scrubber now lined with ChemLine® deliver outstanding corrosion and temperature resistance.

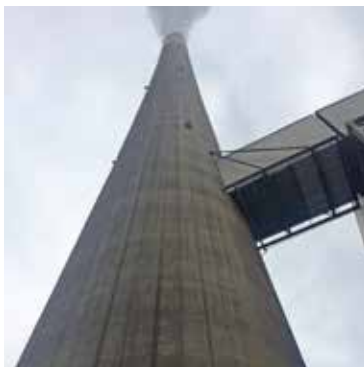
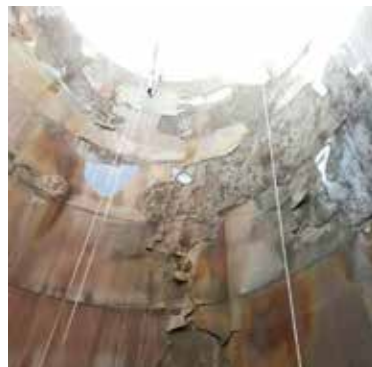
(Left) At this coal-fired power facility the 180 meter high, carbon steel stack lined with a competitor's coating severely delaminated only after 10 months of service as this photo (center) shows near the top of the stack. Normal operating temperature is around 140°F/60°C but at times it reaches up to 233°F/112°C. (Right) After blasting out the previous coating, the top section of the stack is now lined with ChemLine® and

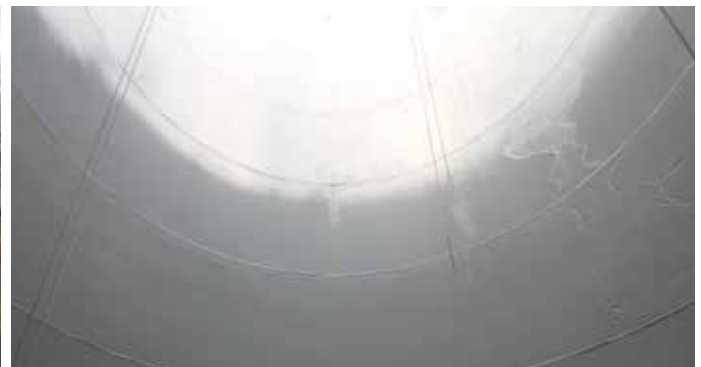
heat cured, covering an area of 20 meters high x 5-1/2 meters in diameter. After successful performance, the customer requested ChemLine® coating be applied to stack tunnels, condenser lines (sea water lines), process water tanks and concrete neutralization pits.

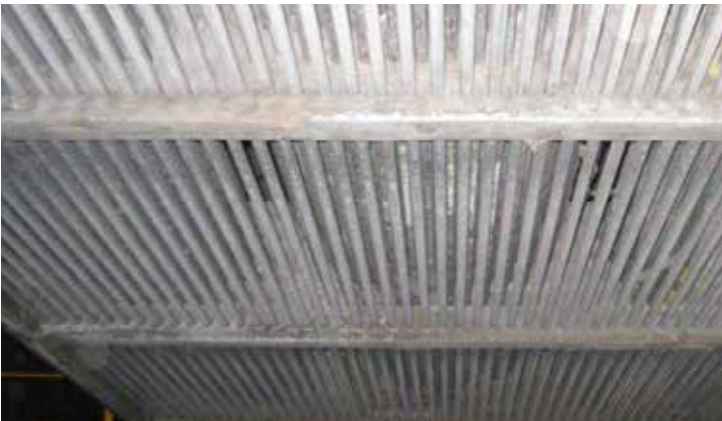
(Left) At this FGD system operation at a coal-fired power plant, flue gas attacks the alloy construction of reheat tubes after wet scrubbing. (Right) The reheat tubes

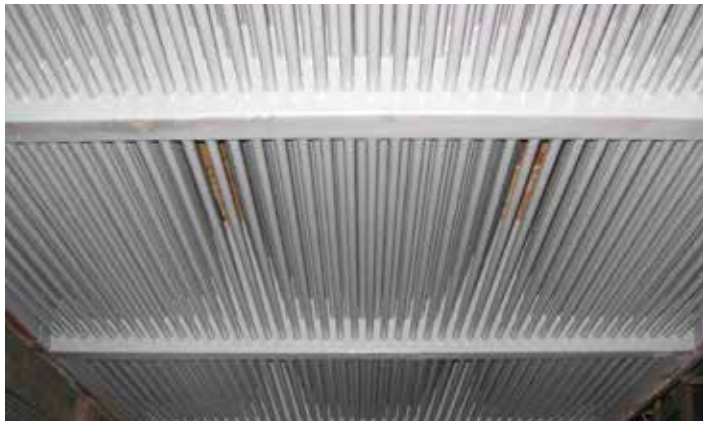
are now coated with ChemLine® and the scrubber is now working at peak performance.
