Advanced Polymer Coatings Provides Tyndall AFB with Environmental Protection

ChemLINE®
CASE STUDY

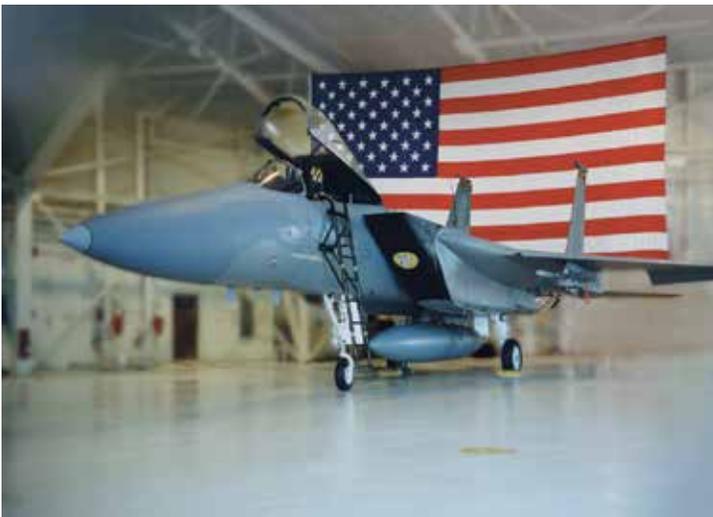
Tyndall Air Force Base with the protective ChemLine® floor coating system.

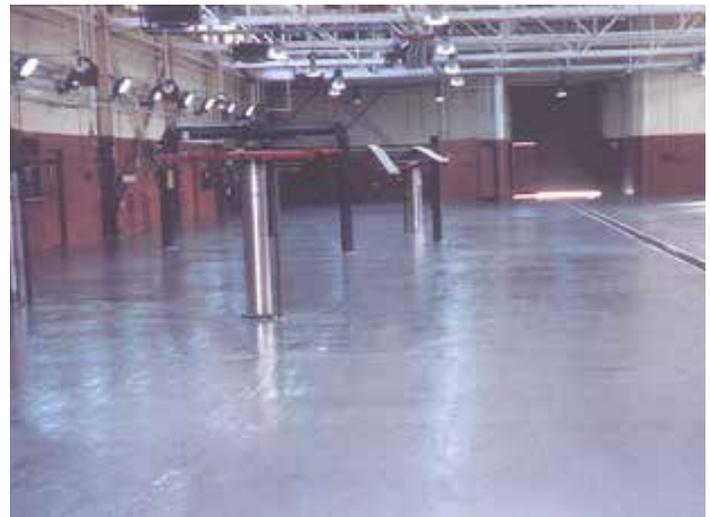
Vehicle maintenance area with ChemLine® coating.

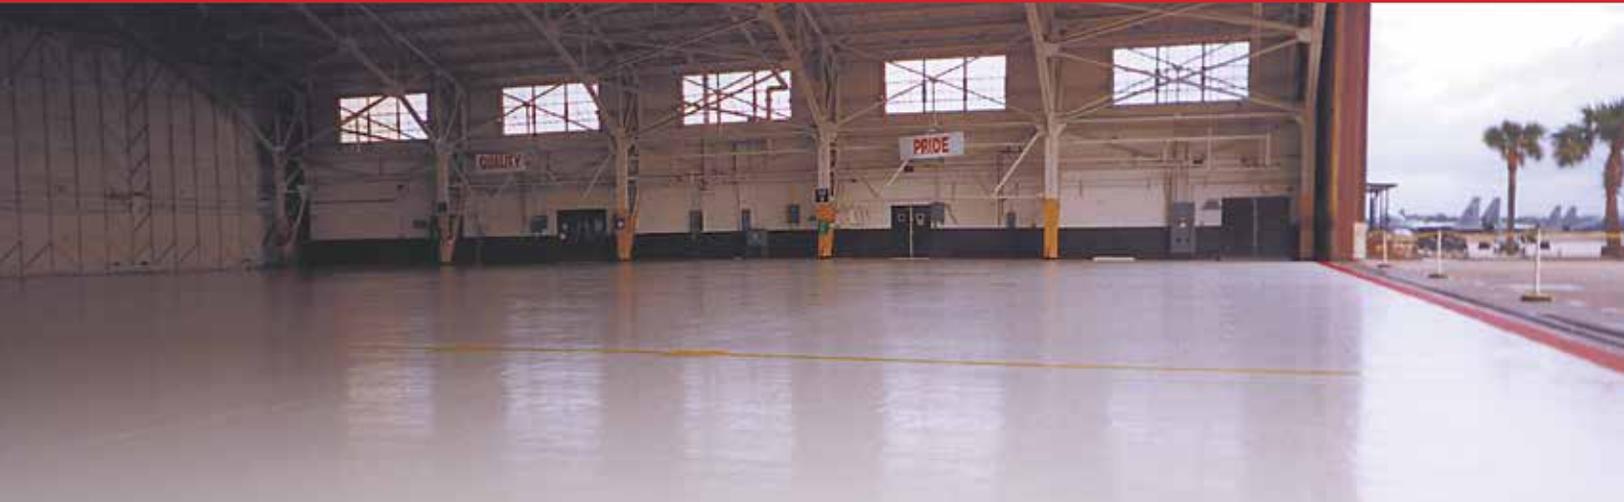
After two years, the ChemLine®-coated floor still looks like new.

The first floors completed over four years ago, according to the officer in charge “are performing above and beyond.” After two years of the most damaging service, problems have been almost non-existent. ChemLine® solved the problems of peeling and flaking, cracking and the need for constant repair. The 200,000 square feet of ChemLine®-treated floors have lived up to the promise. One supervisor adds, “The wear and tear problems have gone away and the use of metal tools, hoses, and equipment have had no effect on the floor. The skid-resistance surface is the best I have seen in 23 years.”

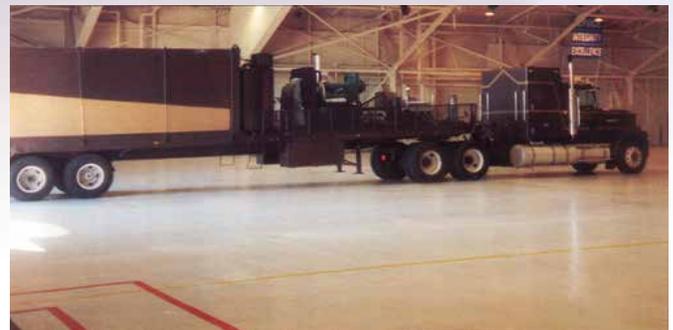
Ultrahigh pressure wash blast at greater than 10,000 PSI does not damage ChemLine®.

The major project then started as a crew completely removed the old floor coating by stripping and blasting with various shot-size combinations. Any cracks and loose concrete were removed and/or repaired, including filling the expansion joints with ChemLine® Caulk. All surfaces were then power washed at greater than 10,000 psig to remove all contaminants prior to coating.
