Wine and Spirit Tanks

ChemLINE®
CASE STUDY

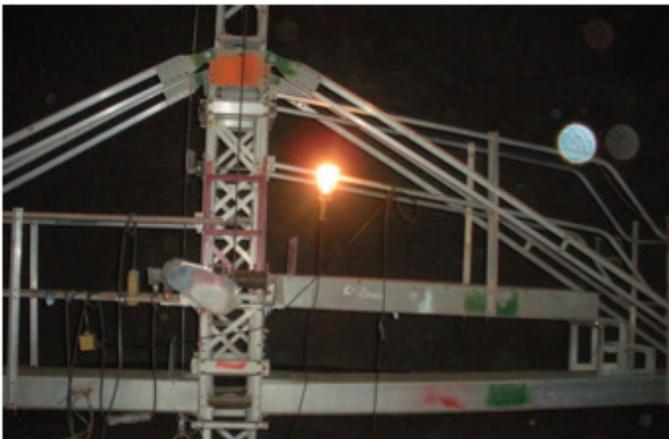
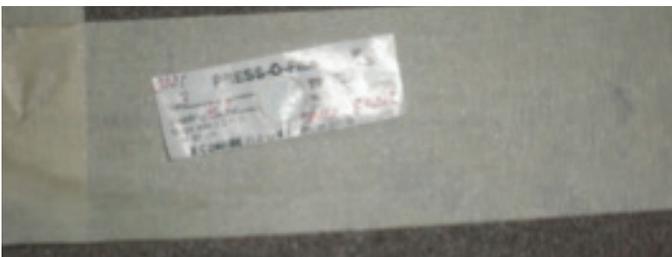
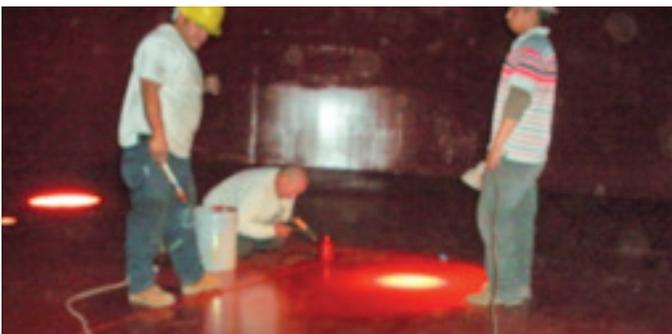
The contractor applied the first spray coat of ChemLine®

784-32 (gray) to the roof and walls and at 6-8 mils (150-200) microns wet film thickness in accordance to the specification.

The contractor allowed the (gray) prime coat to cure to the B Stage and then applied a red stripe coat of ChemLine® to all welds and seams of the tank. This was allowed to cure to B Stage.

A second full coat of ChemLine® 784/32 (Red) at a wet film thickness of 7-8 mils was applied to achieve 6-7 DFT top coat.
