ChemLine® 784/32 Protects Oilfield Tanks in Mexico

ChemLINE®
CASE STUDY

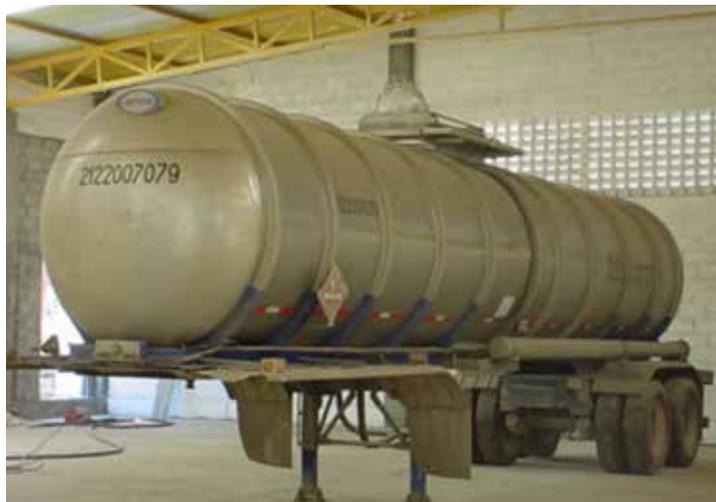
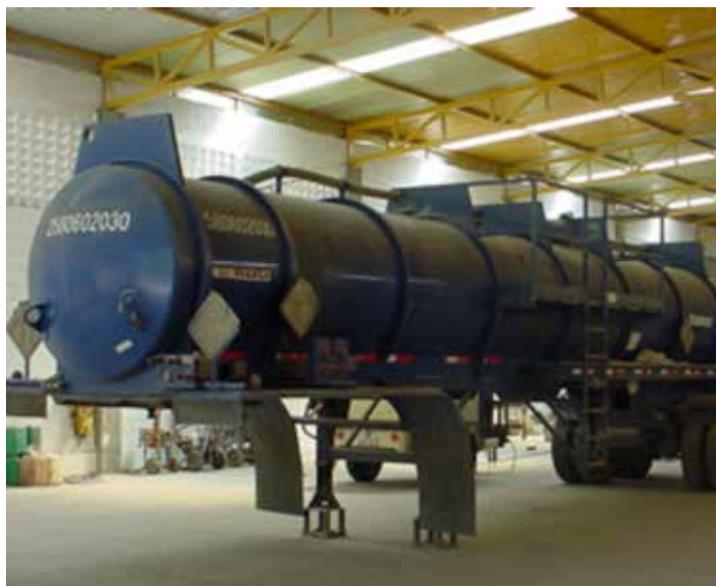
2012 initial application work with two coats of ChemLine® 784/32. First, a grey base coat followed by a red top coat.

Next, a grey base coat of ChemLine® 784/32 was applied followed by a red top coat. The tanks were then forced hot air cured, per coating manufacturer's specifications. Within a few days, the rail tankcars were put back into service.

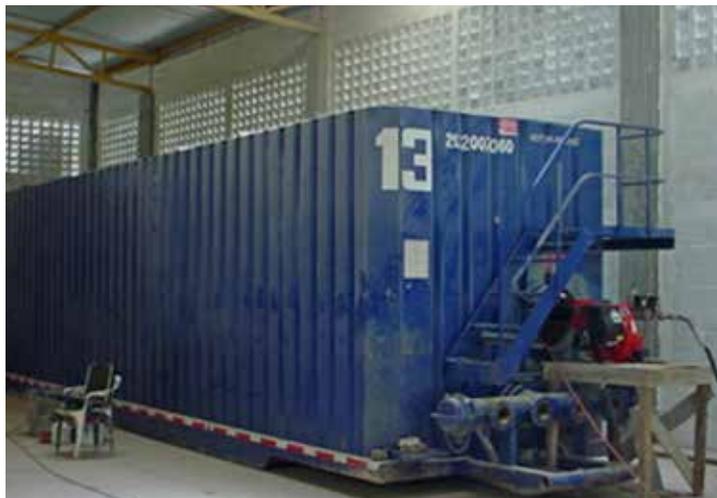
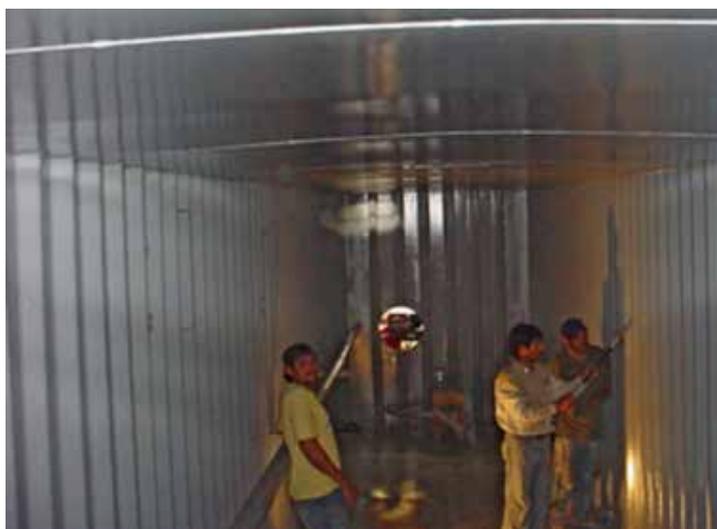
(Top) Fracking tank being readied for internal lining application of ChemLine® 784/32. (Bottom) Inspecting the ChemLine® 784/32 protective coating.

After the coating was applied, it was cured with forced hot air at a temperature of 120°C for 6 hours. This cure provided ChemLine® 784/32 with a high cross-link density with significant corrosion resistance.

All application work was done in a carefully regulated warehouse environment to control all details of the application process. The ChemLine® 784/32 system was applied approximately in two layers of 6-8 mil each (dry thickness) with close monitoring of film thickness, continuity, curing and hardness.

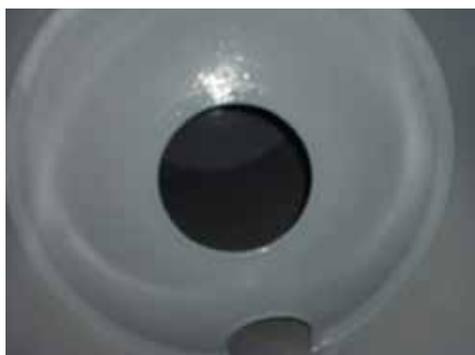
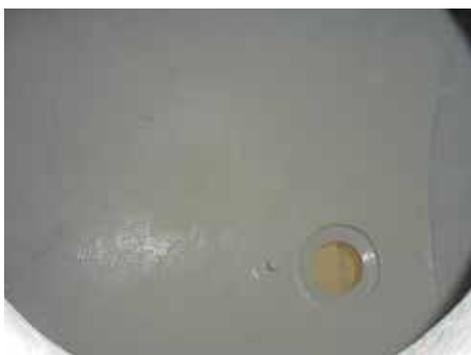
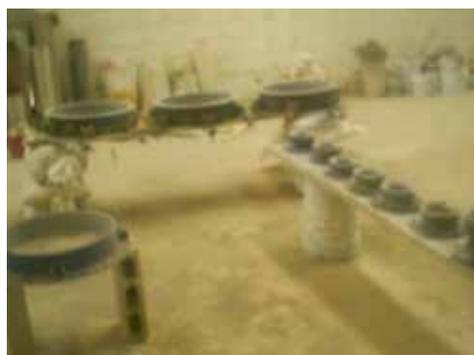
(Left) Inside view showing grey ChemLine®-coated partition inside an over-the-roader tanker trailer, and (center) drain pipe area. (Right) More fracking equipment and accessories also coated with ChemLine® 784/32.

related equipment. All vessels and equipment were lined with ChemLine® 784/32, the patented high functionality polymer coating from Advanced Polymer Coatings in Avon, Ohio, USA. Additionally one vessel was also protected with a specially formulated ChemLine® coating to provide abrasion-resistance service since this vessel handled an erosive product. Fracking equipment accessories were also coated with ChemLine® 784/32 including pipe discharges, caps, flanges, etc.
