Shipping World & Shipbuilder

“ Four Steps to Success ”

*The key elements for ensuring effective
through-life coatings management.*

*By David Keehan
Vice President, Sales & Marketing
Advanced Polymer Coatings, Ltd.*

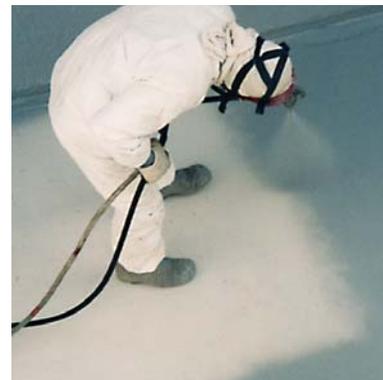
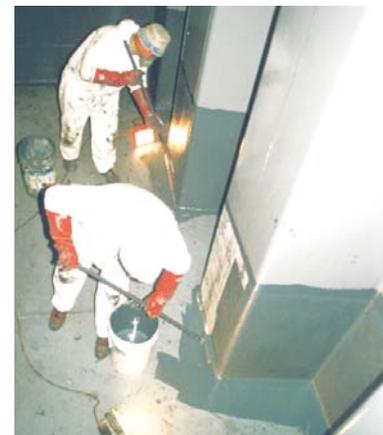
■ Following inspector approval, coating application can commence. Seen here, MarineLine® is applied using the spray (top) and rolled techniques.

MarineLine® coating is provided in separate containers and must be thoroughly mixed in the proportions supplied. The tank coating should be applied in a cross-hatch method to ensure proper coverage and limit the possibilities for pinholes or problems. The higher the solids content of the coating the better the coverage rate. This also limits the opportunity for pinholes and problems to arise. Generally, higher solids tank linings are applied in two coats, with a stripe coat of all welds and critical areas in between.

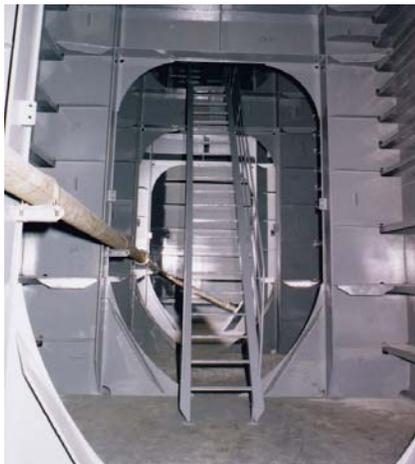
■ Heat curing delivers a uniform and more complete cure of the entire coating application.

Heat curing is performed by inserting long tubes that are connected to natural gas burners into the cargo tanks.

The tubes are brought up to temperature with forced hot air between 80 and 90°C for a minimum of six hours. The temperature is monitored and regulated by the use of computer control and a chart recorder that is connected to thermocouples throughout the tank, thus enabling the tank coating to receive a uniform and complete cure as opposed to having to carry hot cargoes on its initial voyage to achieve a similar result.

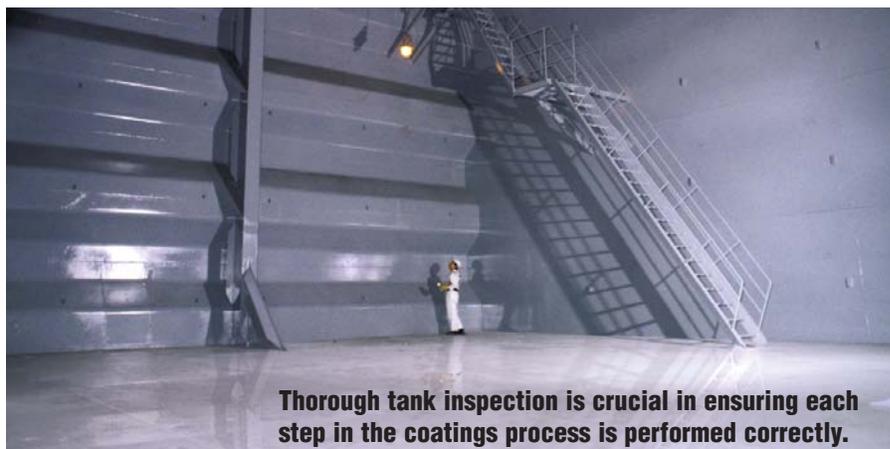
Thorough tank inspection is crucial in ensuring each step in the coatings process is performed correctly.
