## Evaluation of Resistance of Coating ChemLINE 784 in Chloro Acetylic Chloride at 55 °C

**Reference Number** VII.3/14222**Issue** 2 of 2**Client** Chemline (Europe) Ltd,  
Mr. L. Harder**Order date** 2005-10-25**Sign****Received at** 2005-10-25**Subject to be tested** The test is related to the evaluation of corrosion resistance of delivered specimens coated with ChemLINE 784 in chloro acetylic chloride at 55 °C according DIN 50905 and DIN 6601 and of possible changes of coating properties according DIN EN ISO 2178, DIN ISO 4624 and following DIN EN ISO 10308.**Summary** Exposure tests have not shown any significant corrosion effects or corrosion relevant changes of the coating.Therefore the tested coating **is corrosion resistant** in the investigated medium **at 55 °C**.**PRÜFUNGSZEUGNIS**

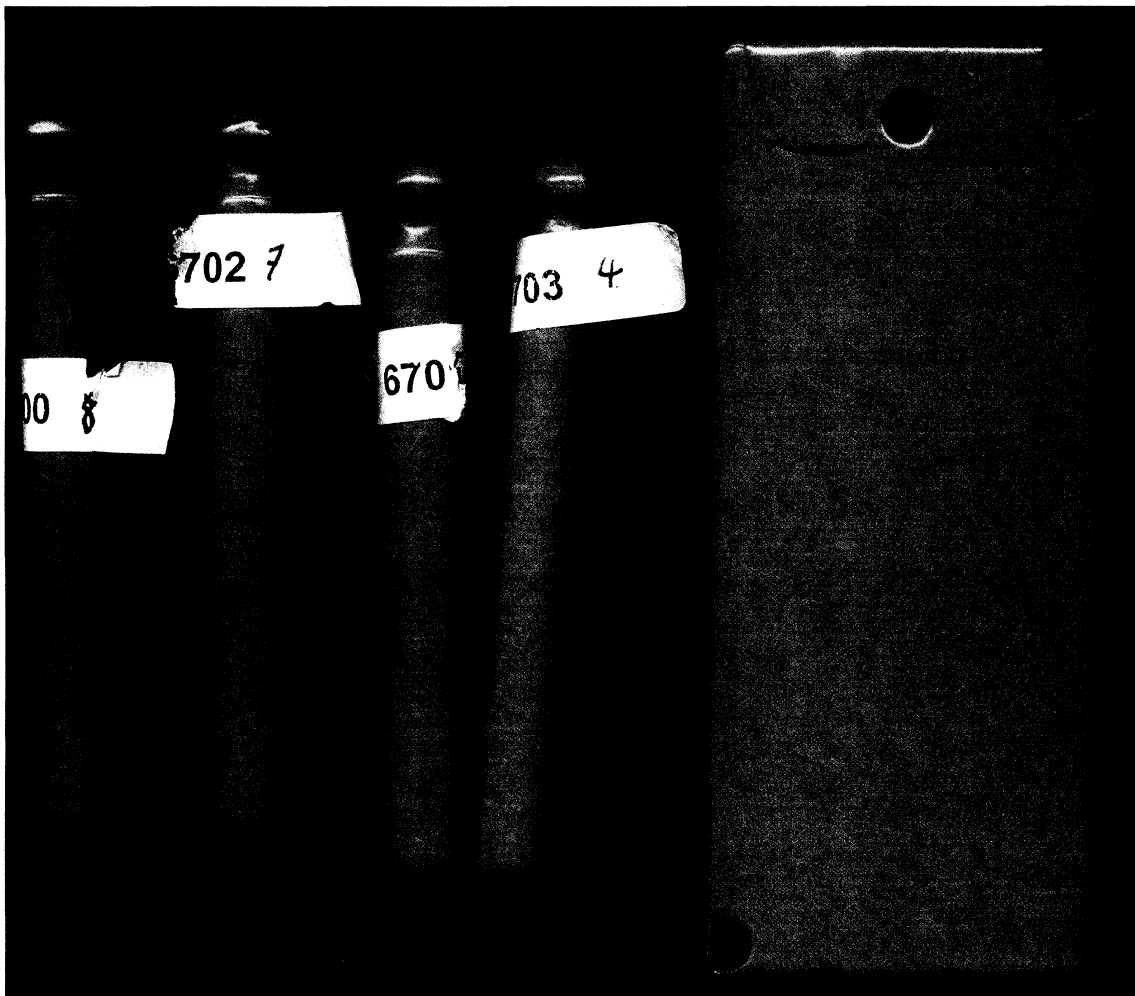
**Figure:** Survey of specimen surfaces after 4 weeks in chloro acetylic chloride at 55 °C

Gravimetric investigations have not shown any corrosion relevant mass loss at all specimens (see figure). No signs of corrosion attack could be observed too. Even at the spalled spots (caused by falling down) on the plate no creeping underneath the coating nor significant corrosion attack at the bare surface could be detected. By thickness measurements a slight swelling of the coating in the range of some  $\mu\text{m}$  combined with a light mass increase was observed.

Apart of a slight darkening of the coating no differences compared to non exposed specimens could be observed.

The slightly brown colorations in the fixing areas are caused by evaporations from the Teflon thread used for fixation.
